# A Review of the Steering Column: Corrosion, Wear, and Mechanical Damage

RESEARCH REVIEW International Journal  
of Multidisciplinary | e-ISSN: 2455-3085  
Double-blind peer-reviewed and  
refereed online Journal  
10(4) 26-33, 2025  
©The Author(s) 2025  
DOI: 10.31305/rrjm.2025.v10.n4.005  
<https://rrjournals.com/>

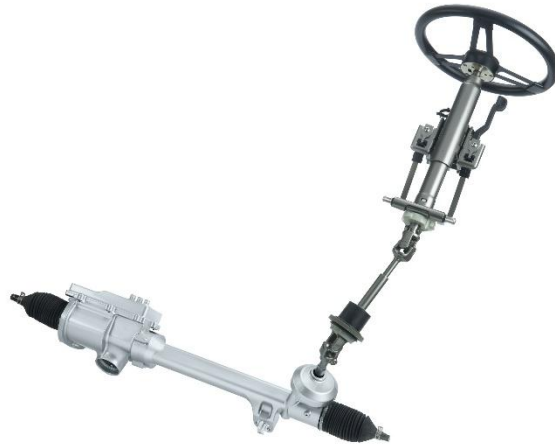
*Fig. 1. Electric steering column [2].*

Modern vehicles, from compact city cars to heavy duty long-haul trucks, play a significant role in the economic and social development of society [1]. As the intensity of traffic increases and vehicle designs become more complex, particular emphasis is placed on the safety and durability of the components. One of the critical parts of every vehicle that directly impacts driving safety and comfort, is the steering column (Figure 1).

In its fundamental operation, the steering column transfers force from the steering wheel to the wheel control mechanisms, while a power steering system (hydraulic or electric) reduces the physical effort required from the driver. This technology simplifies maneuvering in challenging conditions, such as parking or avoiding obstacles, while improving the precision and stability of vehicle control, improving responsiveness to steering input [3]. Despite stringent requirements for the quality of the assembly and materials, steering systems are prone to natural wear and potential failures due to a combination of operational factors, including environmental conditions, road surface quality, maintenance standards, and driving patterns (eg, frequent acceleration, braking, corrosion, impacts, and vibrations). The timely diagnosis of the fault is crucial, as a defective steering column can lead to accidents and substantial repair costs [4].

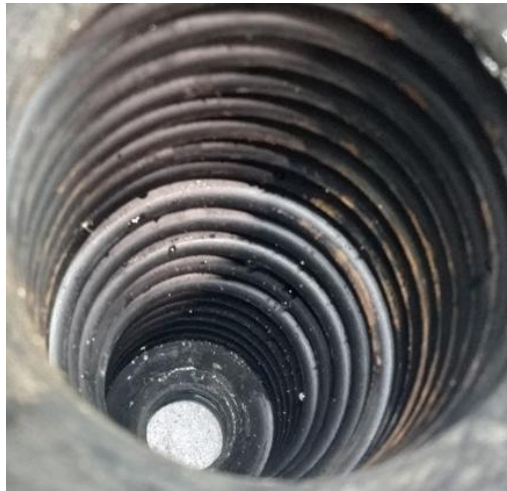
*Fig. 2. Protective rubber with moisture entering.*

The corrosion of internal components typically arises from inadequate sealing. Rubber seals on the sides and fasteners that secure them maintain the stability of the column. If any of these components fail, the seal is compromised and moisture is likely to penetrate, causing corrosion (Figures 2, 3). The hum of the column or jamming is frequently linked to a rusted bearing (Figure 4).

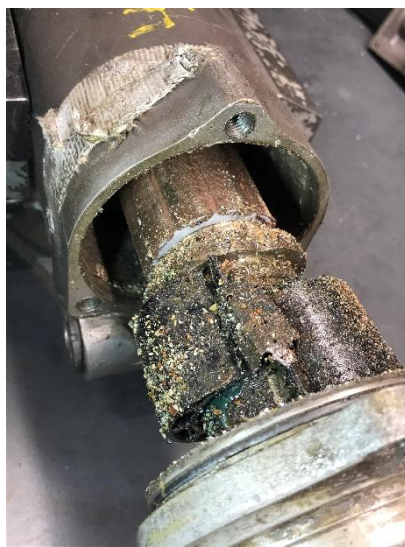
*Fig. 3. Corrosion-affected column.*

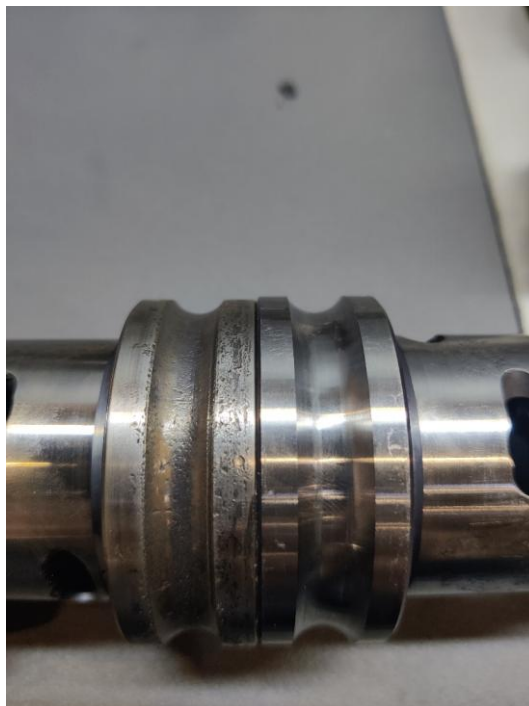
*Fig. 4. Under the left rusty inner part of the bearing. Under the right-repaired inner part of the bearing.*

Corrosion is particularly hazardous, as it can develop unnoticed within the mechanism, causing significant damage over time. Moisture ingress, often due to damaged seals, creates conditions for oxidation of metal parts, reducing their strength and increasing friction. Bearings are especially vulnerable: corrosion can cause them to seize, resulting in humming or complete steering column lockup, posing a critical safety risk.

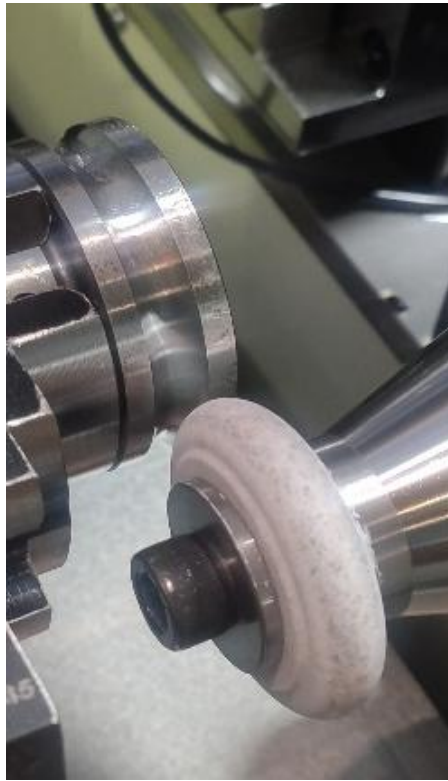
*Fig. 5. Sanding the inner part of the bearing*

1. Disassembly and cleaning of the bearing to remove corrosion, old lubricant, and contaminants.
2. Damage assessment to determine the appropriate repair standard.
3. Bearing inner and outer rings using precision tools to restore the surfaces according to the selected standard (Figure 5). This step requires high accuracy, as the bearings operate within tight tolerances for surface finish, dimensions, and fit.
4. Reassembly with new components: The bearing is rebuilt with new balls or rollers (often larger to compensate for the material removed during machining) and fresh lubricant (Figure 6).
5. Reintegration in the column: the repaired bearing is reinstalled into the steering column housing.

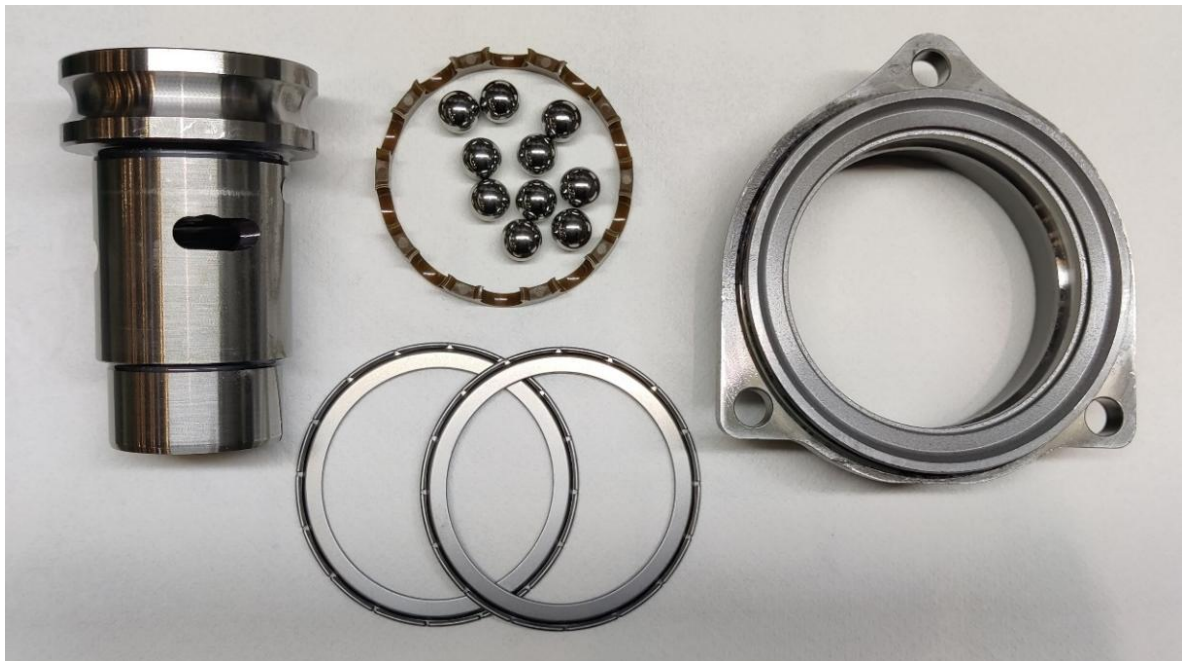
*Fig. 6. Prefabricated bearing with new details*

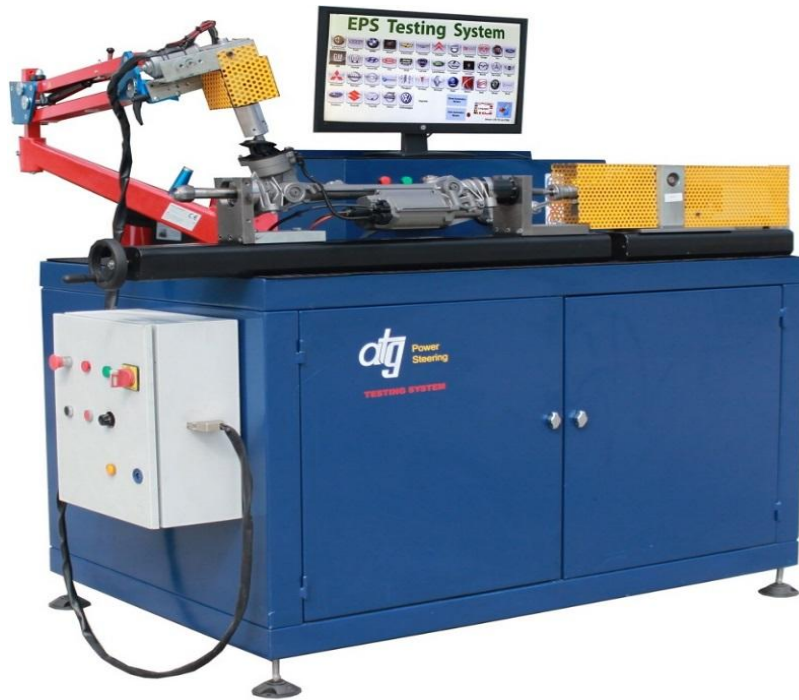
*Fig. 7. Prefabricated bearing with new details*

After repair, the column is tested on a specialized bench that simulates vehicle operating conditions, including driving loads (Figure 7). The bench rotates the input shaft, applies external force through the tie rod, and measures the input shaft rotational force, the column's output force, and vibration levels. Extended testing evaluates the durability of the repair.

In the presented case, a column damaged in an accident initially produced vibrations of 12.5 kHz at a torque of 6 Nm, exceeding the acceptable vibration limit of 6 kHz. After bearing repair, vibrations dropped to 4.5 kHz and torque decreased to 4.8 Nm, meeting the standards (limits: 6 kHz and 6 Nm). This demonstrates the success and the feasibility of restoring the column rather than replacing it.
