# DUGOUTS FROM LAKE *PLATELIAI* AND THE CULTURAL LANDSCAPE OF THEIR SITES

Klaidas Perminas

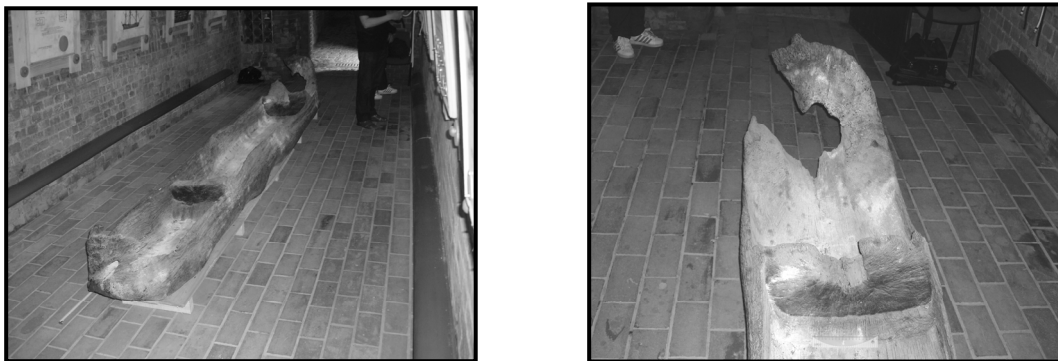
The most interesting is the decorative hole. In our opinion it was designed to pass through a tiller. Tillers are absolutely unusual detail in dugouts, but there is another element in this dugout which supports this idea – the bulkhead at the back part of the dugout (another one is in the front part). It is situated half a meter off the dugout's end and has a 5-6 cm cut in the upper middle part. The cut makes a horizontal line with the hole. Sitting on the bulkhead and steering should be quite convenient and easy in this case (Pic. 2).

Pic. 2. Log-boat Nr. 1 (left) and its back part (right) – the handle, decorative hole and back bulkhead (photo: K. Perminas)

Dugout Nr. 1 was found during an archaeological expedition in the depth of 10 m, not far from the remains of the bridge. The dugout was intact with the length of 4,5 m, width up to 0,55 m. Both ends have a raised form, reminding these of North American canoes. In the front part there is a hole of a prolonged bean form, most probably made for tying up a rope. The back part of this dugout distinguishes for its decorative details – it is „gracefully“ raised, has some other decorative as well as practical elements. The first ones include a brim surrounding the upper part, a decorative leaf-form hole at the very back of the dugout and two deepenings on both sides of the 8 cm long handle, which protrudes from the back part and had a practical purpose – allowed pushing or pulling the dugout.

Unfortunately, there are no analogies known to prove this theory. The front bulkhead also has a decorative element – a widened base at the dugout bottom. Again, such feature does not have any practical sense.
