**Influence of hydrotechnical structures on the dynamics of sandy shores:  
the case of Palanga on the Baltic coast**

**Vytautas Dubra**

Dubra, V., 2006. Influence of hydrotechnical structures on the dynamics of sandy shores: the case of Palanga on the Baltic coast. *Baltica*, Vol. 19 (1), 3–9. Vilnius. ISSN 0067-3064.

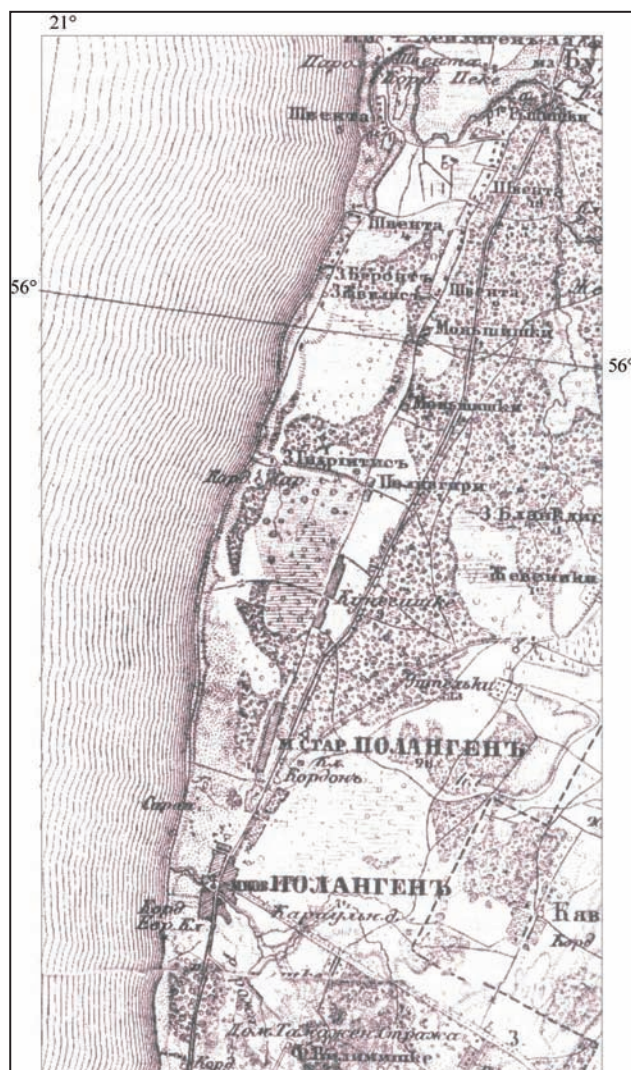
Fig. 2. Map of the suburbs of Palanga issued by General Staff of Russia, 1874 (by the courtesy of the History Museum of Lithuania Minor).

The first one was the process of the coastline movement towards the sea because of the construction of the groyne and partly the wooden pier. Both of these constructions acted for intensive accumulation of sand transport. A map issued by the General Staff of Russia in 1874 shows that there isn't any cape-like formation near Palanga (Fig. 2). The investigated area near Palanga should be marked out for the most frequent recurrence of the southwesterly stormy winds. Strong winds and storms are the main factors on which the formation of the coast within the cyclonic circulation depends. In the course of twenty years process of accumulation caused the appearance of a little cape-like formation,

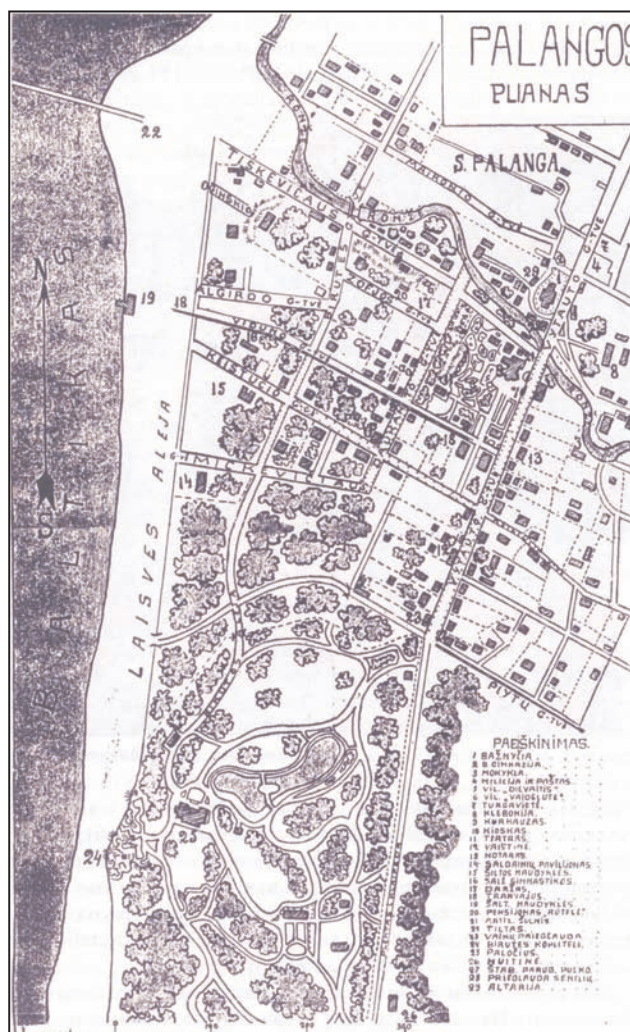
Fig. 3. City scheme of Palanga, 1922 (by the courtesy of the History Museum of Lithuania Minor).

the farthest point of which is about 350 metres away seawards from the former water edge (Karwowski 1913). This little cape is visibly evident on the city map of Palanga that was published in 1922 (Fig. 3). In the course of time this new cape didn't change its geometrical form (Fig. 4). It was because of the cyclonic circulation. The most intensive process of transported sand accumulation took place southwards from the newly installed hydrotechnical structure. Northwards from it a little bend in the coastal line occurred. This structure of water engineering had suffered considerable damages during storms of hurricane strength. The greatest damages were made by hurricanes and storms of October 1967; January 1983; January 1993; December 1999; and January 2005.
