# Cross-Shore Profile Evolution after an Extreme Erosion Event—Palanga, Lithuania

**Abstract:** We report cross-shore profile evolution at Palanga, eastern Baltic Sea, where short period waves dominate. Cross-shore profile studies began directly after a significant coastal erosion event caused by storm “Anatol”, in December of 1999, and continued for a year. Further measurements were undertaken sixteen years later. Cross-shore profile changes were described, and cross-shore transport rates were calculated. A K-means clustering technique was applied to determine sections of the profile with the same development tendencies. Profile evolution was strongly influenced by the depth of closure which is constrained by a moraine layer, and the presence of a groyne. The method used divided the profile into four clusters: the first cluster in the deepest water represents profile evolution limited by the depth of closure, and the second and third are mainly affected by processes induced by wind, wave and water level changes. The most intensive sediment volume changes were observed directly after the coastal erosion event. The largest sand accumulation was in the fourth profile cluster, which

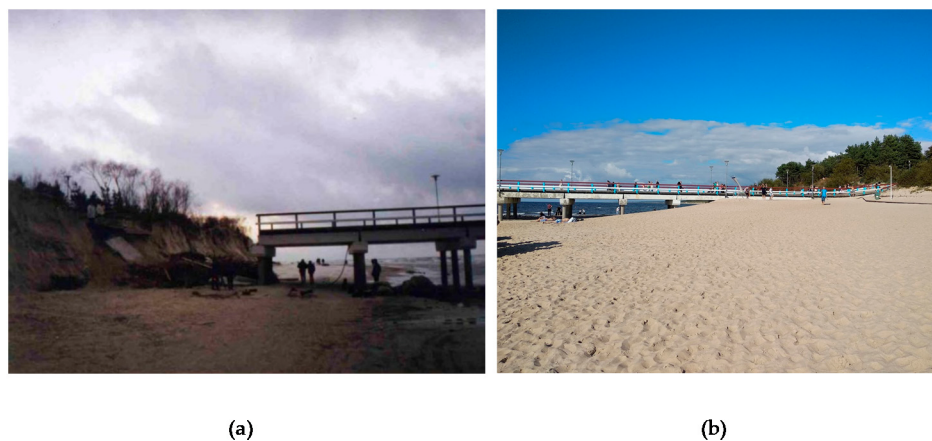
**Figure 2.** (a) Palanga pier after the storm “Anatol”, December 1999, and (b) in September 2018.

Storm “Anatol” remains the most damaging storm recorded on the SE Baltic Sea coast [33,34] with predominant west and north-west wind directions, mean wind speed up to 22 m/s, and maximum wind gusts reaching 40 m/s [33]. “Anatol” stands out as being unusual for the Lithuanian coast by its trajectory over the Baltic Sea [35] resulting in up to 40 m/s south and south-west winds. Several comparable storms have since crossed Baltic Sea, examples being Ervin (or Gudrun) in 2005 and Kiril in 2007 [36,37] but they were more hazardous on the NE Baltic Sea coast [31,38,39]. During the storm “Anatol”, more than 3 million m<sup>3</sup> of sand were eroded from the Lithuanian Baltic Sea coast [34], which at Palanga caused a 35 m reduction in beach width [31] and resulted in the dune base moving inland by 10 m [11,31,32]. The pier was damaged at its landward end and detached from the shore (Figure 2a), and the dune system was destroyed [30]. As a result of the changes, the groyne system (Figure 1b) was rebuilt in May 2000 [32].
